### **TEST REPORT**

Report No.	L0599(E)/63	
Operation No.	TC2020090030	
Name and address of customer	LEEWATTANA PRODUCTS CO.,LTD.  110,112 PHANITCHAYAKARN THONBURI Rd., WATTHAPRA,  BANGKOKYAI, BANGKOK 10600	
Sample description	Sample was submitted and identified by/on behalf of the customer as following:  Wall-Mounting Enclosure  Model: CA 710  1 set	
Sample No.	TC2020090030	
Sample characteristic and condition	Normal	
Sample received date	September 14, 2020	
Test date	September 21, 2020 – September 22, 2020	
Issue date	September 23, 2020	
Test standard	TIS. 513-2553 (IP54)	
Test report	Details of the test report as shown on the following pages.

### Sample photo

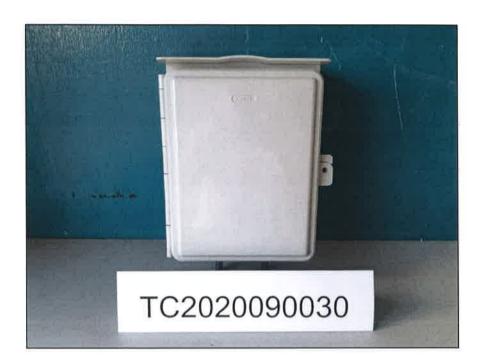
Model ....: : CA 710

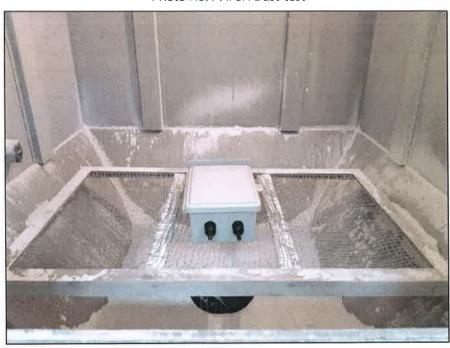
Photo No.4: IP5X Dust test

13.3	Acceptance conditions for first characteristic numerals 1, 2, 3, 4		
	Full diameter of the object probe did not pass through any opening		
13.4	Dust test for first characteristic numerals 5 and 6		Р
	Category	2	-
	Duration	8 h	<b>3</b>
	The test is made using a dust chamber incorporating the basic principles show in figure 2 of IEC		-
	60529:2001 whereby the powder circulation pump may be replaced by other means suitable		
	to maintain the talcum powder in suspension in a closed test chamber. The talcum powder		
	used shall be able to pass through a square-meshed sieve the nominal wire diameter of which		
	is 50 µm and the nominal width of a gap between wires 75 µm. The amount of talcum powder		
	to be used is 2 kg per cubic metre of the test chamber volume.

Clause	Requirement – Test	Remark	Result
13.5.2	Acceptance conditions for first characteristic numeral 5		Р
	No deposit of dust was observable inside th	-

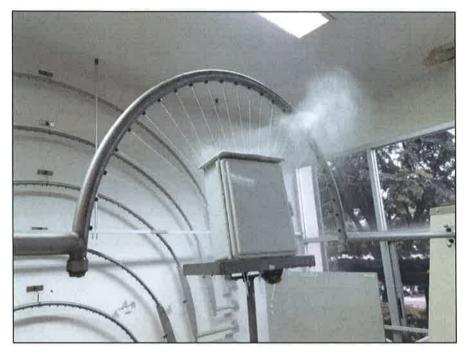
Photo No.5: IPX4 Water test

14.2.4	Test for second characteristic numeral 4 with the oscillating tube or spray nozzle		Р
	Test means	Oscillating tube	H
	Water flow rate	1.8 Vmin	₩2
	Test duration	10 min	<b>3</b> €

14.3	Acceptance condition		Р
	No water was found inside any of the enclosures		7 <u>2</u> 2
15.	TESTS FOR PROTECTION AGAINST ACCESS TO HAZARDOUS PARTS		N
	INDICATED BY THE ADDITIONAL LETTER

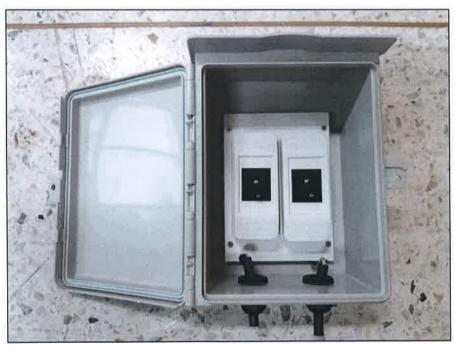
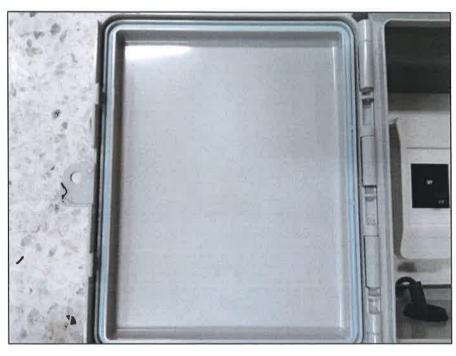
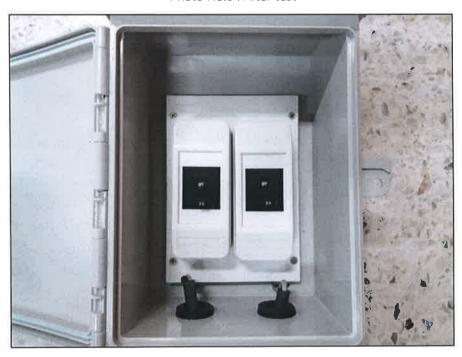
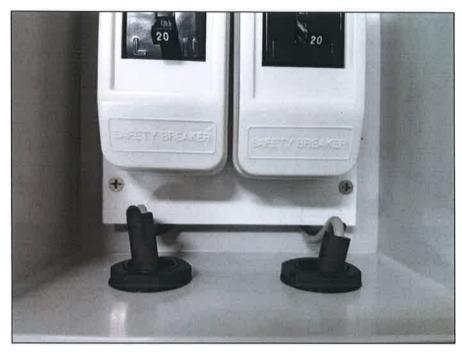
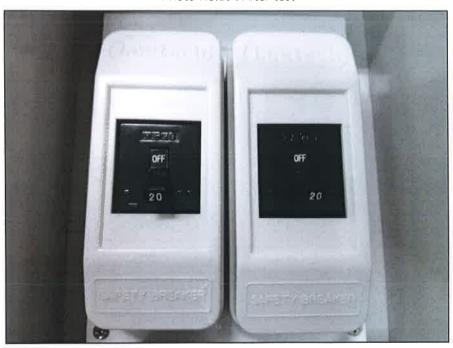
Photo No.6: After test

Photo No.7: After test

Photo No.8: After test

Photo No.9: After test

Photo No.10: After test
